ORNL-4905

## BLAST TESTS OF EXPEDIENT SHELTERS

FINAL PROJECT OFFICERS REPORT - LN316

JANUARY 1974

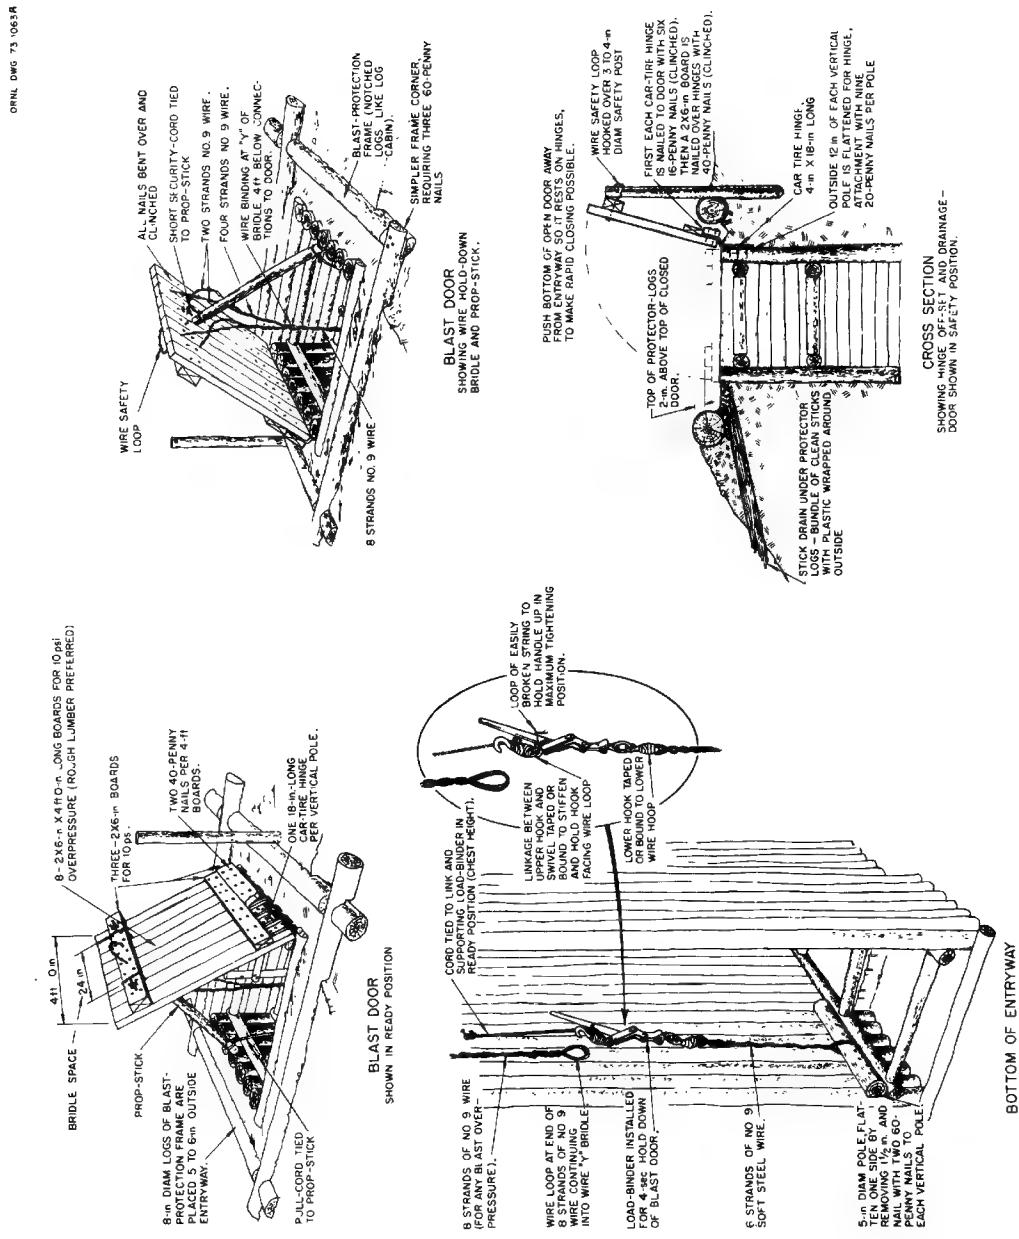
Figure 4.1 Expedient Quickly Closable Blast Door, as Used for Small-Pole Shelter.

4.3.1 Expedient blast door LN316-6 was located on azimuth 100°, 840 feet from GZ. The predicted overpressure was 15 psi; the measured,  $16.7 \pm 1.5$  psi. The two center boards were badly cracked in their middles, but were not broken. No other damage resulted. The surrounding wet earth was compacted by the blast, but was not blown away.

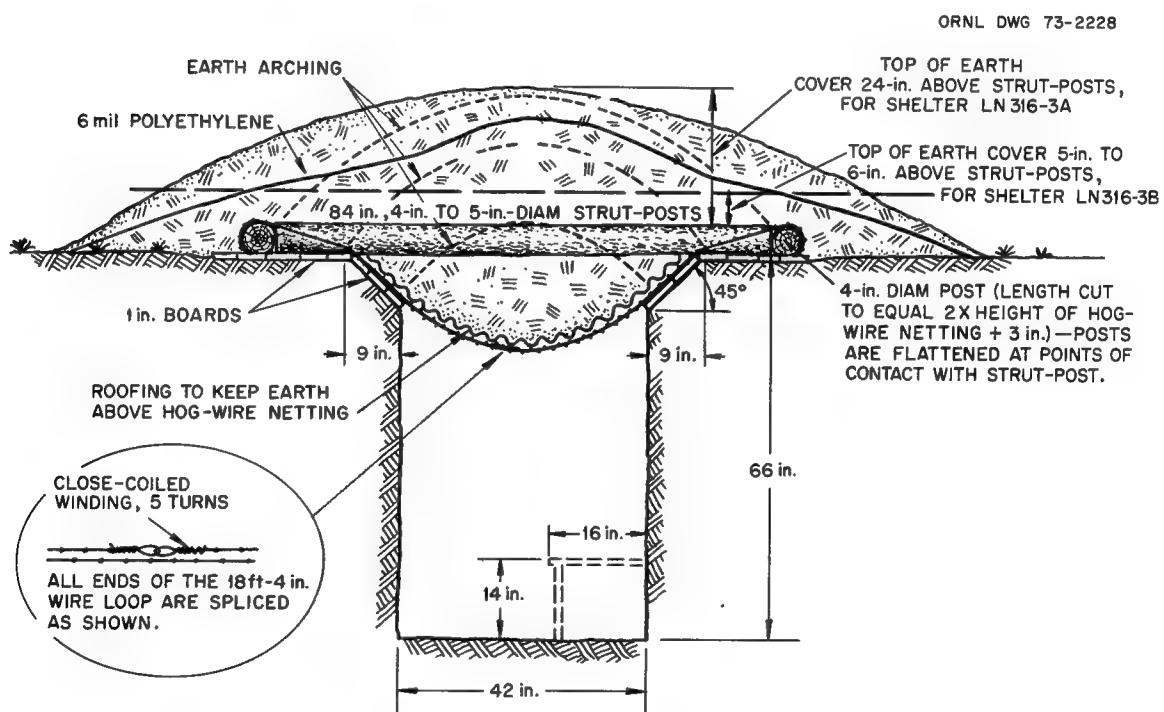
Figure 5.1 Wire-Catenary-Roofed Shelter.

Neither of these closed shelters was consequentially damaged. The shock wave shook only very little earth from the trench walls, as is indicated in Figure 5.4 by the insignificant amount of fallen earth on the black plastic. Only after the earth cover was removed from around the frame posts was any damage noted: one of the brittle cedar

strut-posts was found to be broken in two where its diameter suddenly changed (because of branching) from 5 inches to 3-1/2 inches. However, the packed earth around this strut-post held the broken ends together so that it obviously continued to function effectively as a compression member of the frame.

No doubt the short duration of overpressures high enough to severely stress LN316-3B, combined with some earth arching in the "inadequate" earth covering of this shelter, caused the permanent downward deformation of its roof to be less than anticipated. As shown by Figure 5.1, the depth of earth in which arching could occur in LN316-3B is the vertical distance from the bottom of a 45° slope of unexcavated earth on which the roof wire rests, up to the top of the earth cover--about 21 inches. Apparently, in the sandy earth of the Mixed Company test site if the ratio of the effective depth of the earth cover to the effective free span of the earth arch is 1/2 (21 in./42 in.), then effective arching will result under blast loading.

The blast overpressure further compacted the damp earth mounded over LN316-9, but, rather surprisingly, the blast wind removed very little of the wet earth from its mounded covering. The trench walls (which except for the uppermost 12 inches of sandy soil were of an earth that verged on a soft argillaceous sandstone) remained essentially unchanged. The center part of the wire "catenary" was depressed only about  $1/4$  inch relative to the "bedrock" floor of the shelter roomlet-- indicating that very effective earth arching\* supported most of the surface load of about 29 psi overpressure. See Figure 5.1.

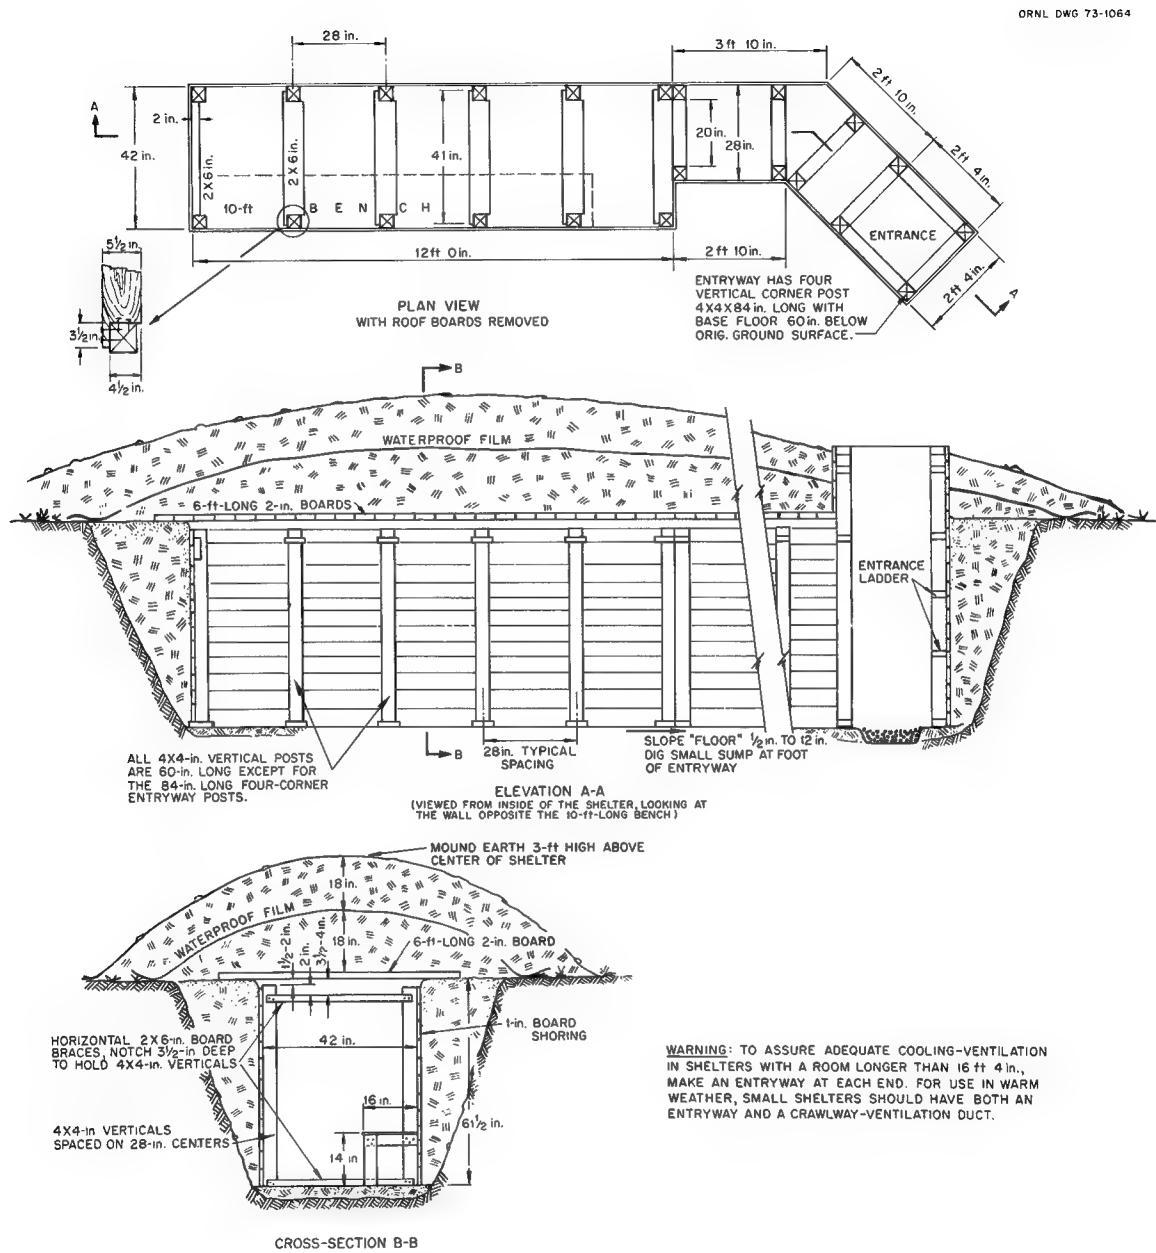
Figure 6.1 Shored-Trench Stoop-In Shelter.

To limit the load on the shoring to the horizontal pressures of the earth pressing against it, the 6-foot-long, 2-inches-thick roofing boards rested only on the packed earth outside the shoring, and not on shoring boards. See Cross-Section B-B of Figure 6.1.

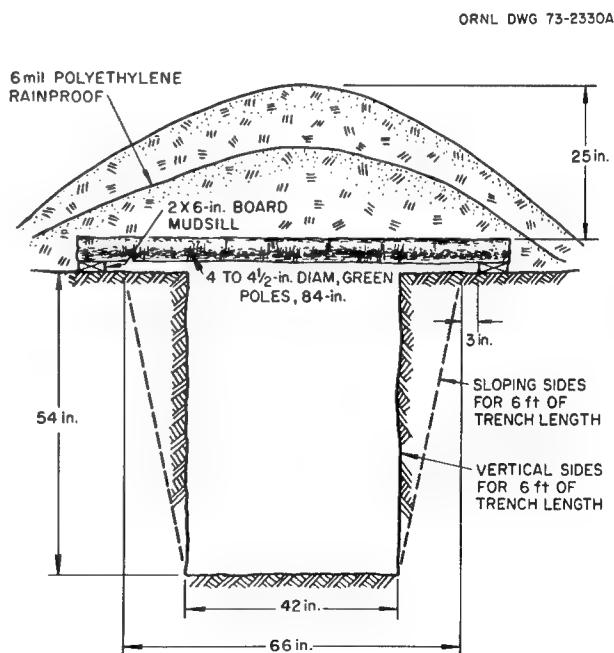
Figure 7.1 Log-Covered Trench Shelter LN316-9A. Note the mudsills under the ends of the minimum-sized roof "logs".

To obtain another measure of the effectiveness of earth arching, one of these shelters (LN316-4A) had the full earth cover shown in Figure 7.1. The earth was mounded 25 inches above the tops of the roof "logs", as measured after its compaction by the blast overpressures. The other shelter (LN316-4B) had the top of its blast-compacted earth cover only 8 inches above the roof "logs".

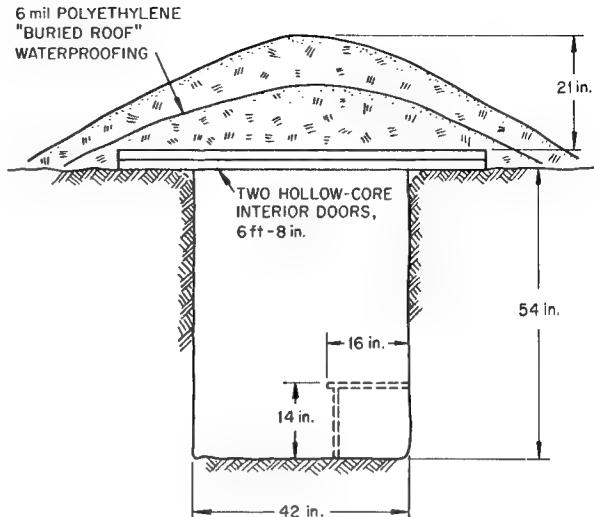
Figure 9.1 Door-Covered Trench Shelter.

The double thick roofing doors were bowed downward almost 1 inch--approximately twice as much as were the full-dimensioned 2" x 6" boards that roofed the far end of the shelter. Most of the downward bowing occurred due to static loading from the earth cover during the month before the blast--as was also the case with LN316-5B.

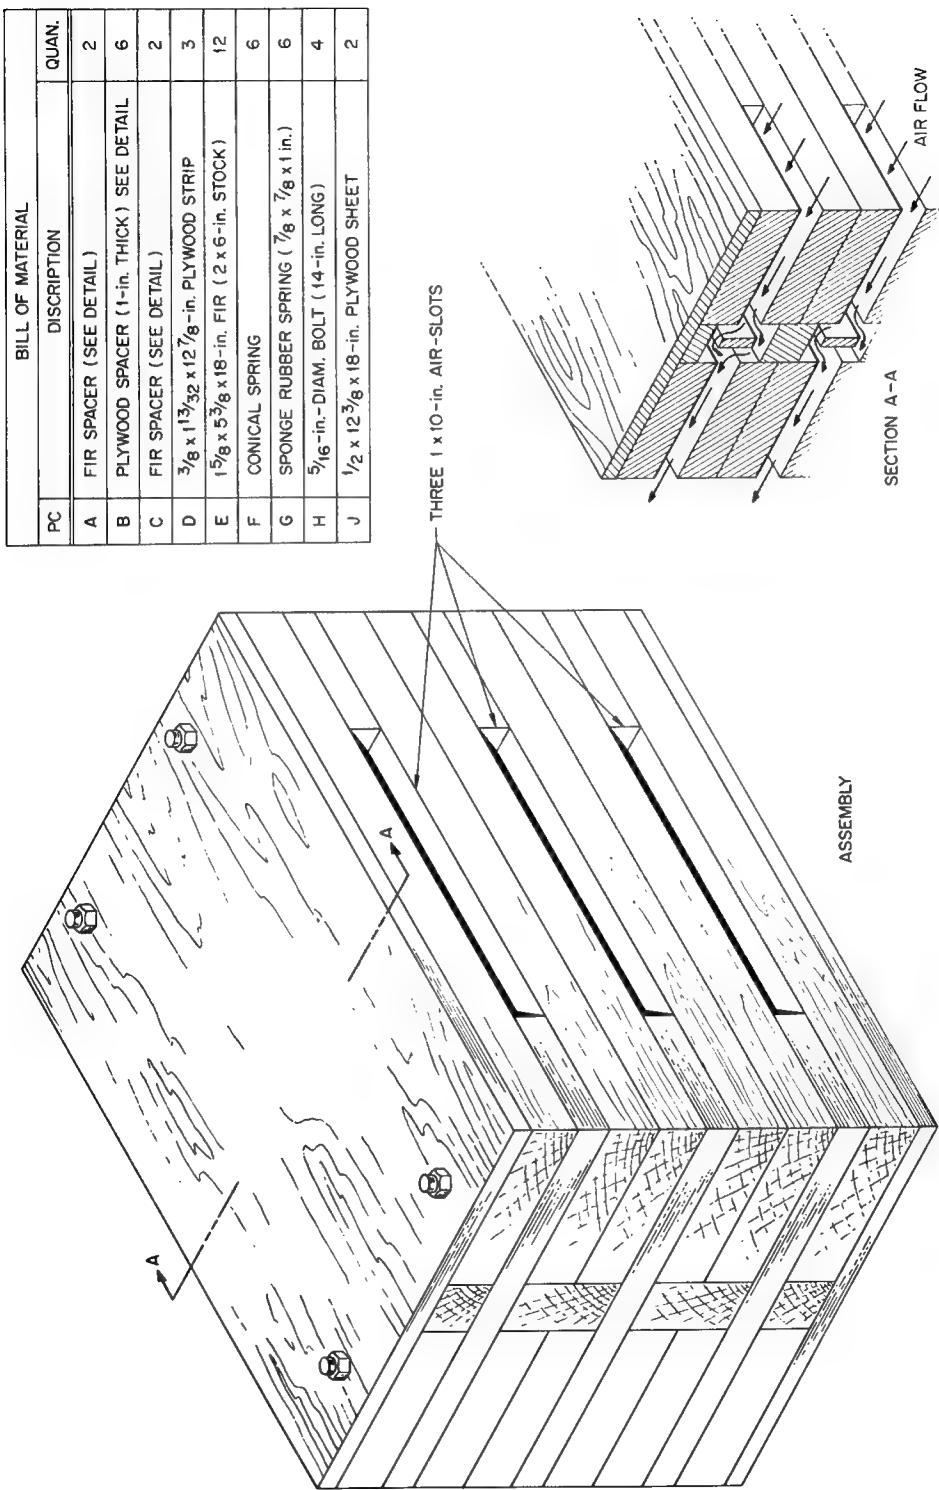
Figure B.2 Caged-Strips Blast Valve LN316-11B. LN316-11A was identical except for one of its "caged" plywood strips being 1/2-in. thick, instead of 3/8-in. thick.

Upon disassembly, all the plywood strips and their steel springs and foam rubber "springs" were found to be in excellent working order. The bases of the foam rubber "springs" were still glued securely to the wood in their recesses. Only some thread-sized, blackened pieces of sagebrush had been blown around the two right-angle turns and far enough to reach the plywood strips. This very lightweight blastborne material did not interfere with the movement of the valves or their
